Inspection Report Minerals Regulatory Program April 12, 2010

Mine Name: Italian TanPermit Number: S/007/0038Operator Name: Quality Building StoneInspection Date: 03/24/2010Inspector(s): Brett Gregory for Wayne WesternTime: 11:00 amOther Participants: NoneMine Status: Active

The operator asked for an inspection to release the bond. At the time a full inspection was not intended nor planned for without the presence of the landowner and mine operator.

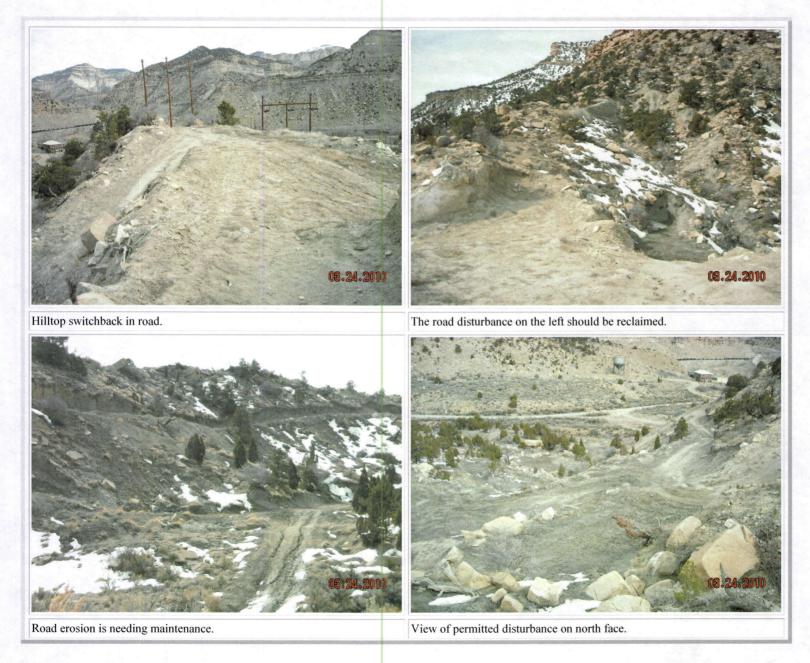
Inspection Date: 03/24/2010 Page 3 of 4 S/007/0038

The site appeared stable. Only two issues were noteworthy:

- 3) All road disturbances should have erosion control and post-mining land use maintenance.
- 10) Non-designated road disturbances and some small mining areas need to meet 70% revegetation standards. An approved seed mix should be determined by the Division and implemented by the mine operator.

The landowner must assume in writing full responsibility for the non-reclaimed road before the bond can be released to the operator. Additional measures should also be taken by the operator to control the erosion found on site (i.e. installation of water bars, silt fences, berms, trenches, etc.). I would further recommend the entire road be seeded with the other disturbed areas in order to help stop the formation of reels and road ruts.
